"Fixing" the LDG Z100 ATU

25 March 2011

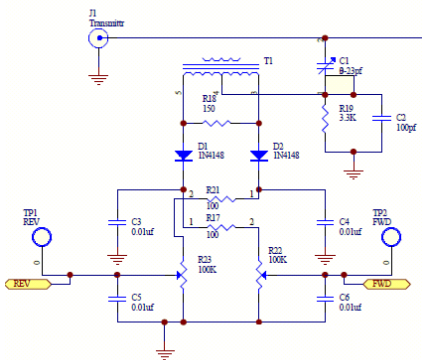
This is the SWR sensing circuit. It is a fairly typical arrangement and unless the 3-23pF trimmer is faulty/lossy, there isn't much here to cause a high input VSWR.

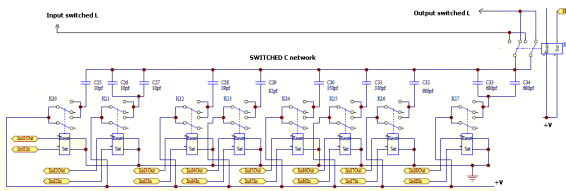
This is the switched capacitor network. Unlike the inductor arm, these relay contacts are arranged to either open-circuit or short-circuit the path to the individual values of physical silver mica capacitor. Remember, capacitors in parallel add their values together. By using 8 capacitors that can be selected in any combination, there are 256 possible values of capacitance available. Actual values are 10pF, 20pF, 40pF, 82pF, 150 pF, 33pf, 680pF, 1360pF giving a maximum capacitance of 2340pF and a minimum approaching zero (0pF) with all relay contacts open circuit.

If one of the relay contacts in the actual capacitor switching network is faulty, it will be either open-circuit or high resistance. Note that both sets of relay contacts in each physical relay are paralleled so reducing the likelihood of this area causing the slow rise. The fact that it happens at 7 MHz as well as 50 MHz means that the selected values of C to obtain an impedance match are going to be widely different.

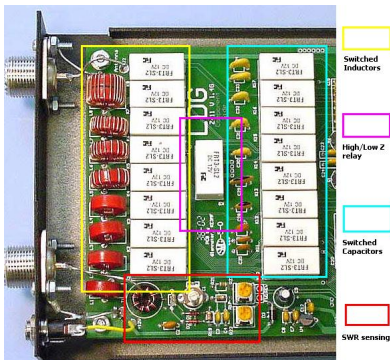
The RF section of the Z100 PCB layout follows the same trend as the Z11 image shown here. The microprocessor part of the unit has been updated to reflect the later technologies but it still does the same thing : measure the forward and reflected voltages and either sets, or re-sets, individual latching-style relays.

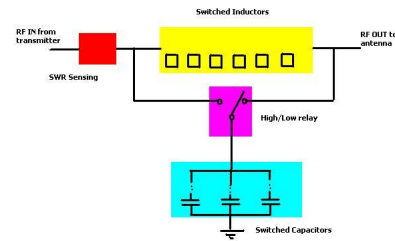
LDG Z11/Z100 concept

The interesting part of the schematic at left, and made more obvious by this conceptual block diagram, is the relay contacts at the upper right hand segment. This relay switches the capacitor "bank" (or switched C network) across either the input or output connection thus creating either an "L-network" impedance transformation network either up or down in ratio, i.e from 50 ohms to a higher impedance (eg 50 to 1000 ohms) or from 50 ohms down below it (i.e 3 to 50 ohms) .
