## The "VK4ADC" Family Caravan

September 2012

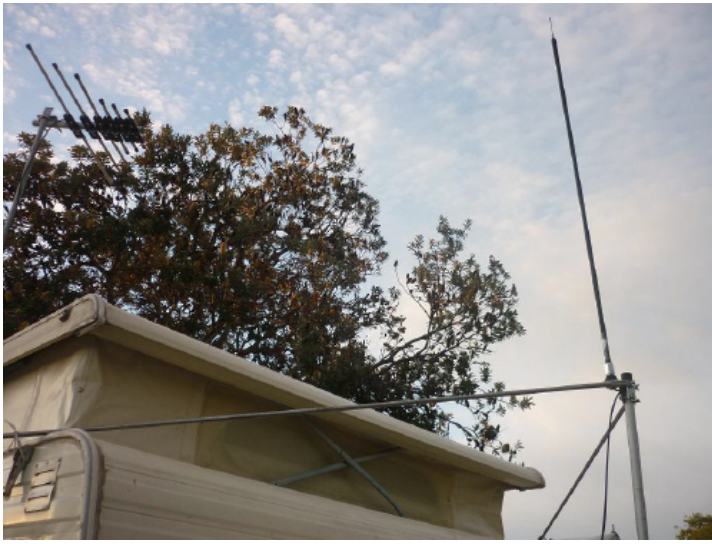
Of course, it wouldn't be a 'VK4ADC' caravan without some antennas - in this case, a homebrew LPY-style TV antenna with 3 elements for 180 to 230 MHz (VHF digital channels) and another 3 elements for 530 to 690 MHz (UHF digital channels) plus a pipe mount for 5/16"-based whips for the amateur frequencies. The two 1.8m-long aluminium tube radials are insulated from the van's frame - without them, the SWR is horrible on 6m and 2m. With them in place, it is < 2:1 on both bands. Strange what a difference an almost-groundplane makes ???

Of course there was a need to provide for my AR activities too so the pipe mount on the front drawbar was included, a 1.8m long removable pipe added and a 5/16" antenna base arrangement for whips provided. What used to be a 300-ohm ribbon TV antenna feed socket on the outside wall is now a BNC female via foam RG58-style coax to a BNC plug in the 'sofa' area.

The van then went to the beach for 10 days, Pottsville Beach actually, in northern NSW. All went well, no major problems were encountered with the van or it's setup. I had added a couple of 1.8m long aluminium tubes to fit as radials for this outing and made SWR measurements before and after their fitting : wow, what an improvement. Needless to say, they will be fitted from now on ! Whilst not proposed for field day activities, more for family holidays, the selection of whips along for the ride allows for portable operation on the 3.5, 7, 10, 14, 21, 28, 50, 146 and 439 MHz bands. The Icom IC-706MK2G plus Z100 auto ATU and a small DSE switched mode 12V 20A power supply all strapped together make for a small AR station to take along on holidays.. PS : The still-to-do list from that trip was quite short.
