**2010 Winter VHF/UHF Field Day**

VK4ADC/P in QG61OU  
Australia

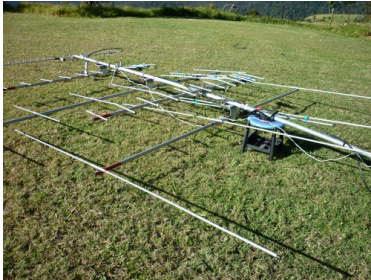
9:48AM - the antennas mostly assembled, feeders in place, white H/V polarisation change rope fitted.

No spanners or screwdrivers (or other tools) are actually used anywhere in the establishment of the FD station - wingnuts are used throughout. Sizes vary - 3/16", 1/4" and 5/16" - all Whitworth - but it makes the assembly process quicker.

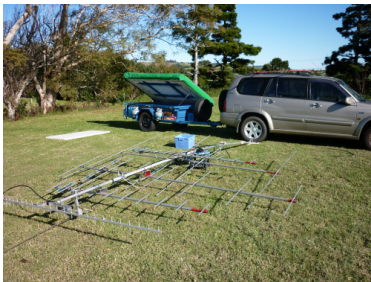
9.48AM : alternate view showing the positioning of the tilt base under the rear wheel of the 4WD - and, yes, the mast tube bends !!!! The 23cm & 70cm antennas plus the support stool and the white blow-mould table arrived in the camper trailer base - hence it still being open.

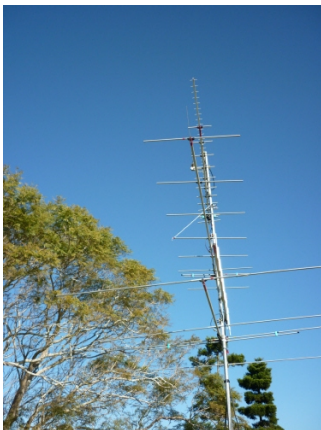
9.52 AM - the antennas are up. The white rope at near dead-centre of this photo is the H/V polarisation change - maybe seen a little more clearly in the photos are right.

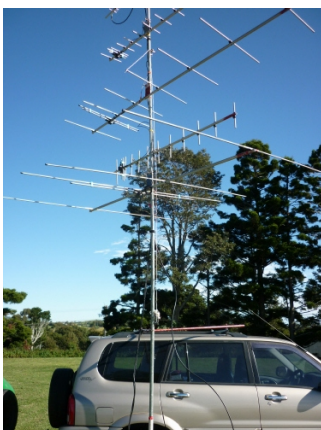
9.52AM - this view shows the red stabilising bars at the 4WD roof level. One 25mm dia tubular steel bar comes directly towards the camera and bears a 68mm u-bolt that the mast tube passes through vertically, the diagonal brace to the front bar is bolted through the rear bar and has a number of vertical holes to sit over a protruding bolt (& wingnut) fitted to the front bar. Once the diagonal brace is in position, the mast tube just doesn't move - except azimuthally 'on demand'.

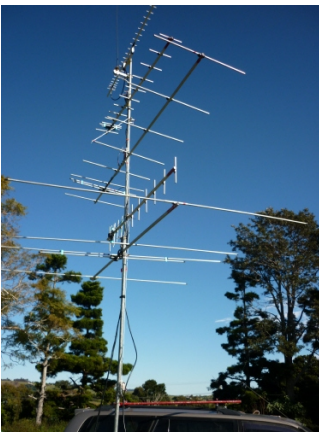
From top to bottom :

Fibreglass whip to LHS top used for 50.15/52.525, 146 or 439 MHz.

Top yagi : 23cm horizontal, fed via LMR400 cable

70cm yagi, horizontal polarisation - although this is hinged so can be used for vertical as well if the pull-rope is fitted.

2m yagi, horizontal for 144.15 but with the pull-rope fitted allows operation at 146.5 for FM simplex.

70cm yagi, fixed in vertical polarisation - for 439Mhz FM

6m yagi - hinged for ease of erection but is used mainly at 50.15 though a few contacts were made on 52.1 & 52.15 on SSB during this FD outing..

The feeders for all except the 23cm yagi are low loss RG58-size foam coax - Cellfoil 9006 from RFI - zip-tied into a harness for ease of installation, N male connectors on the top ends and BNC male on the bottom ends.

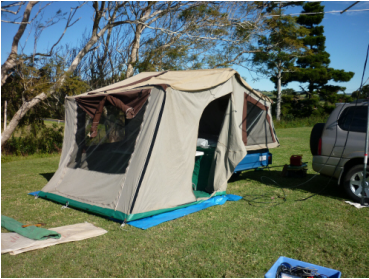
10.15AM - the camper trailer has been disconnected from the 4WD and rotated 180 degrees so the main entry point into it is North - i.e. nearest the mast tube - to make rotating the antennas quicker. Why North ? The predominant bad weather comes from the south east or south west so having the door flap at the north makes it relatively unnecessary to close it.

The blow-mould table is in place, some gear is on it although not yet connected.

The camper "tent" section was held down by just two tentpegs on the outside corners instead of the normal quota of about 12. The front roof was not erected as it would have meant putting up the supporting poles, more tentpegs.. and wasn't really considered necessary if there wasn't much wind - although the sun almost on the notebook screen had not been anticipated.

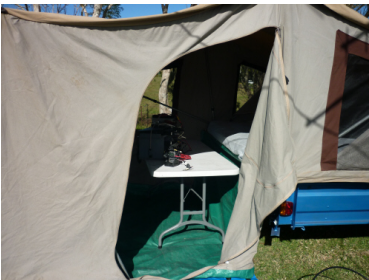
10.15AM - looking in the flap of the camper. The Yaesu VX7R used on 439 FM is visible in the sunlight, the rest is shaded.

The camper was not 'tensioned up' - just a very quick setup. The front annex piece was left folded over the roof of the main section as it wasn't considered absolutely necessary - although the sun "backlighting" the notebook screen (see next photo) could have made a difference there - had the notebook use continued.

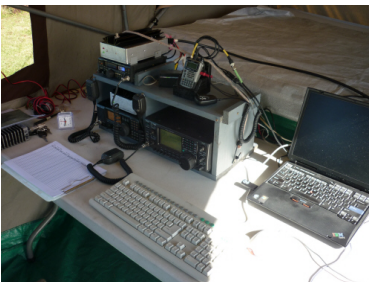
11.28AM - the gear is all set up, powered on, the noise from the IBM notebook discovered and the the notebook powered down. Note the paper log sheets on the table ready to go in 1/2hrs time.

From top to bottom, left to right :

top - 23cm SSB/FM station - Kenwood TR751A & homebrew transverter.

bottom - 432 SSB station - Icom IC-718 (28MHz IF) & homebrew 70cm transverter.

middle top - 439FM - VX7R with external speaker /mic & power input, external coax feed to vertical yagi

bottom - 6 & 2m station, SSB & FM - Icom IC-7400

right - IBM R31 notebook that won't find it's way to a FD ever again !!!!
